Principle	NDIR
Range	0 ~ 50%vol CO ₂
Sampling Mode	Pumping
Response Time	≤ 3 s (@500 ml/min)
Recovery Time	≤ 3 s (@500 ml/min)
Long-term Stability*	≤ ±0.01%vol/month
Temperature	0 °C ~ 40 °C
Tolerance	±0.1%vol ± 3% True Value (Full Temp.)
Resolution	0.01%vol/sec @ 0~5%vol 0.05%vol/sec @ 5~20%vol 0.2%vol/sec @ 20~50%vol
Zero Temp. Drift	±500 ppm
Reading Unit	ppm
Detection Limit	0.001 %vol

DATASHEET

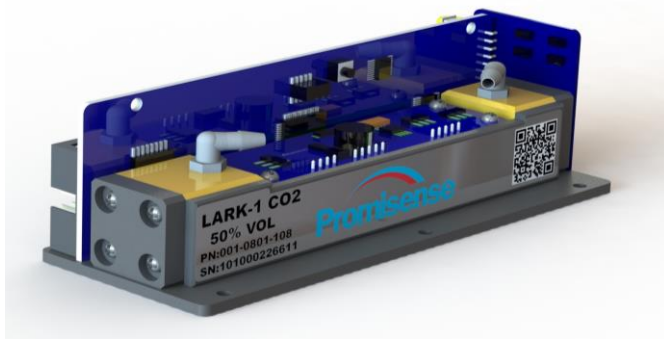
Optic Path	Steel
Circuit Board	FR4 / Lead-free HASL
Solder	Sn / Ag / Cu
Mounting Plate	ABS

- Length: 126 mm ± 1 mm
- Width: 51 mm ± 1 mm
- Height: 39 mm ± 1 mm
- Weight: 208 g ± 5 g
- Screw Hole Diameter: 3 mm

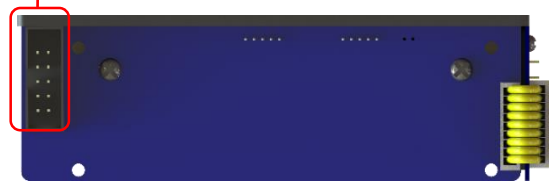
Connector Definition

1.ALM	2.V _{out} (DAC)
3.RXD(TTL)	4.TXD(TTL)
5.RXD(RS232)	6.TXD(RS232)
7.CS1*	8.GND
9.PWR DC	10.GND

*CS1: 0-3.3 VDC Output, for RS485
